**SAS Superstructure**

Location: 04-SF-80-13.2 / 13.9

Daily Diary Report by Bid Item

Diary #: 714 Const Calendar Day: 159 Date: 10-Nov-2012 Saturday

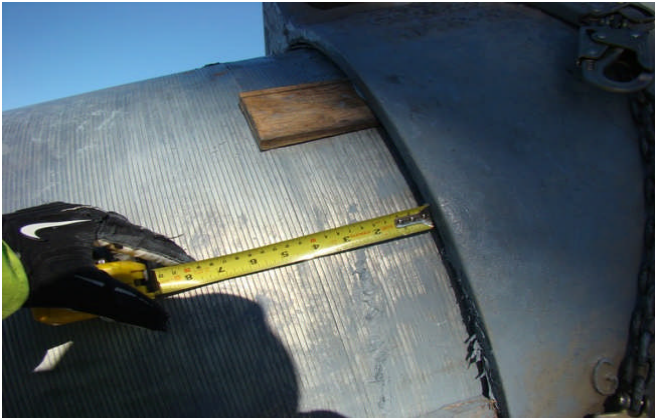
Hand wrapping shown on the downhill side of cable band 12S where there was a significant bulge 4" from the machine wrapped portion w/cadweld splices

1.) A significant bulge was observed in the S-wire wrapping 4 inches away on the downhill side of cable band 12S. This was shown to Roman Granados and Victor Pereyra so that they were aware of the situation. Roman discussed this issue with ABF foreman Mike Drapier, engineers Adam Reeves and Adam Roebuck. They proposed to remove the cadwelds located at 12 O'clock or on the top of the cable and try to reshape the slacked S-wire before placing new cadwelds.

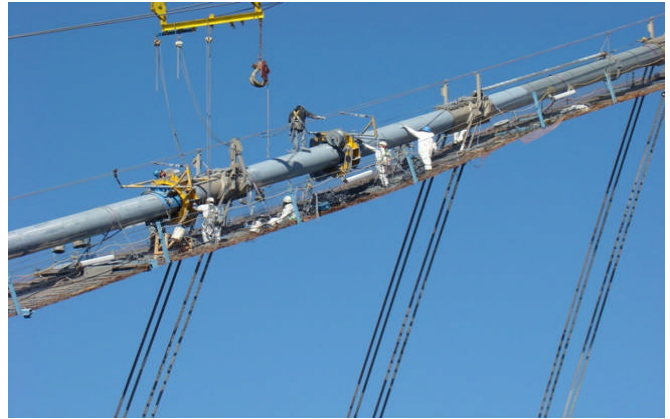
ABF ironworkers in the process of wrapping the North Sidespan main cable with S-wire.

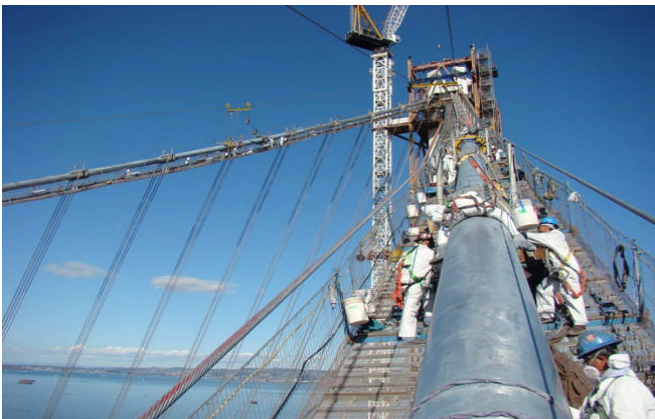
Wrapping operations on the North and South Sidespans today.

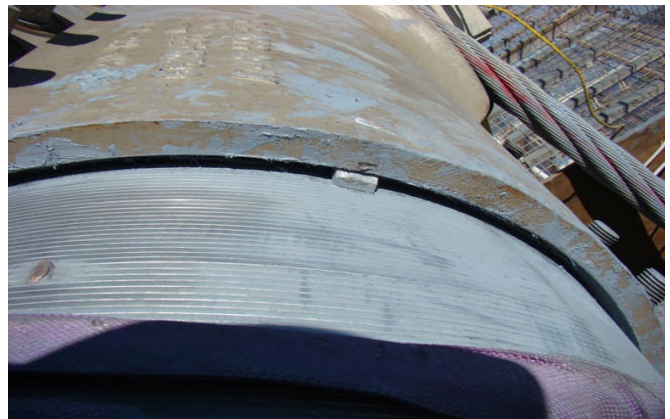
A termination wedge seen at a South side span cable band casting where the cable band gap wasn't $\leq 14\text{mm}$ to wrap the S-Wire around the bolt.

3.) S-wire hand wrapping on the downhill side of cable band castings 16S and 18S were completed and found to be acceptable. The cable band gaps at both locations were $< 14\text{mm}$. Therefore wedges were used to secure the S-Wire in the downhill portion groove of the castings. Six wedges were used and all of the wedges were 7-part.

5.) Wedges used at the cable band casting appeared to be driven properly into the groove. A noticeable elastic deformation of the S-wire was seen which ensures proper seating of the wedge against the S-wire, wedge, and cable band casting groove.

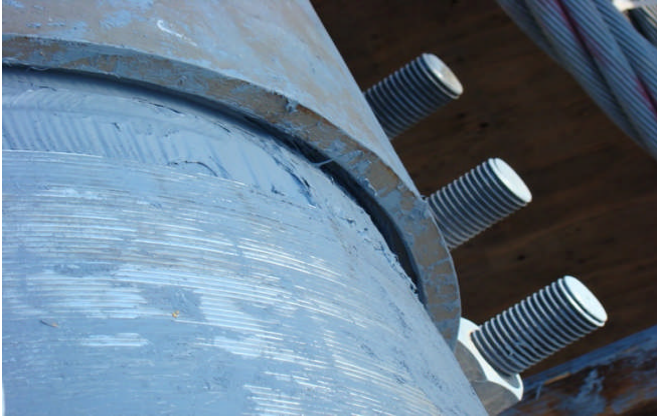
Zinc paste applied near a cable casting on the South Sidespan today as ABF crews were informed to apply a thick coat in this area.

Yesterday Victor Pereyra was inspecting this operation as he emphasized to the crews that more Zinc paste should be applied near the casting as the main PWS wires were exposed. See a photo below for how the Zinc paste should be applied which wasn't done until laborers were informed. Other pertinent notes from today's S-wire hand wrapping operation on the South Sidespan are the following:

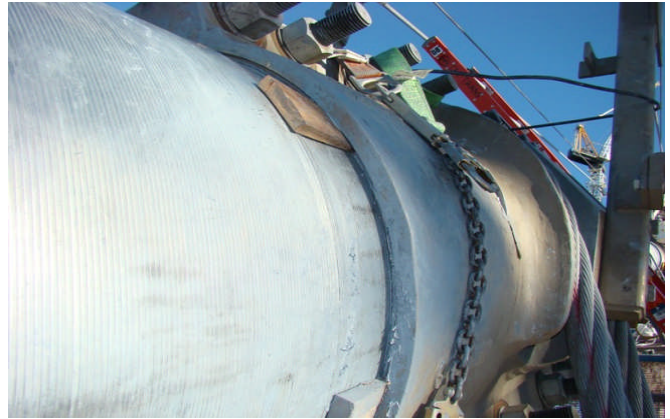
Bulge of the S-wires on the downhill side of cable band 12S looking uphill on the outboard side.
